**Bare Mitigation Site  
Unnamed Tributary to Peak Creek, Ashe County**

**Monitoring Report**

**NORTH CAROLINA DEPARTMENT OF TRANSPORTATION  
STREAM MITIGATION PROGRAM**

**Period covered October 22, 2002 to July 7, 2004**

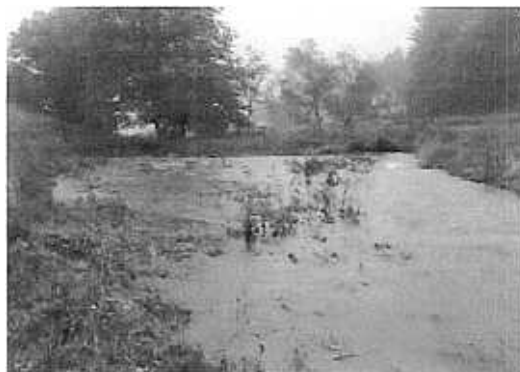
**LDS stn. 1+78 - 3+21 after work & during flood September 27, 2002**

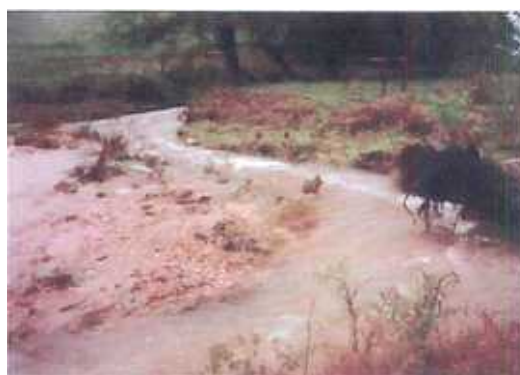
**LDS XS 2+90 during flood September 27, 2002**

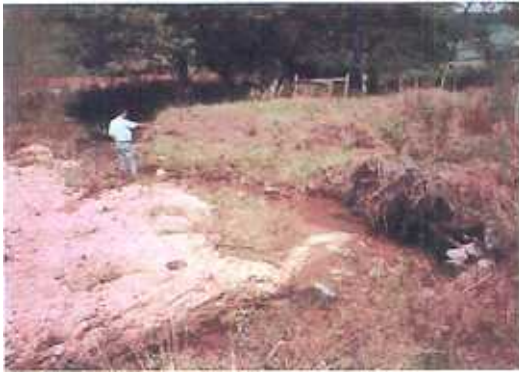
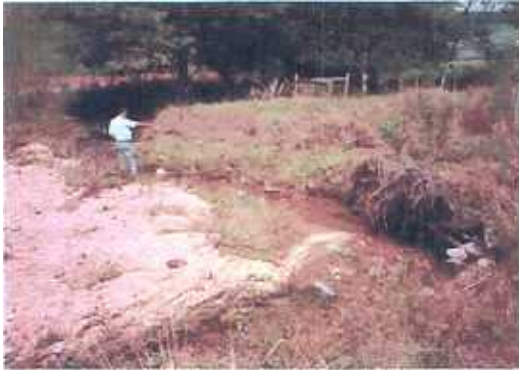
LDS XS 2+90 after flood October 4, 2002

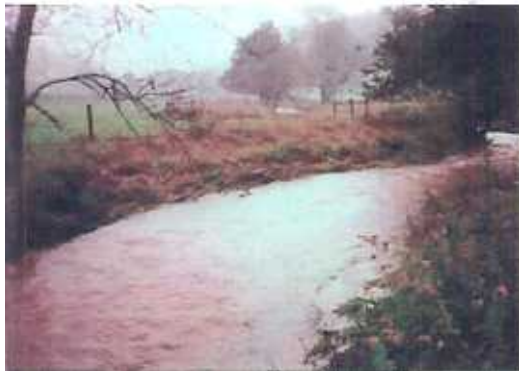
LUS stn. 5+50 after work & during flood September 27, 2002

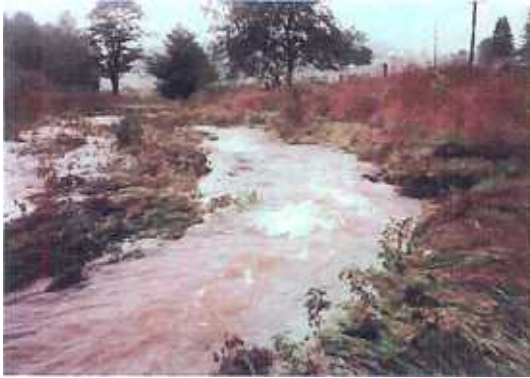
LDS XS 7+19 during flood September 27, 2002

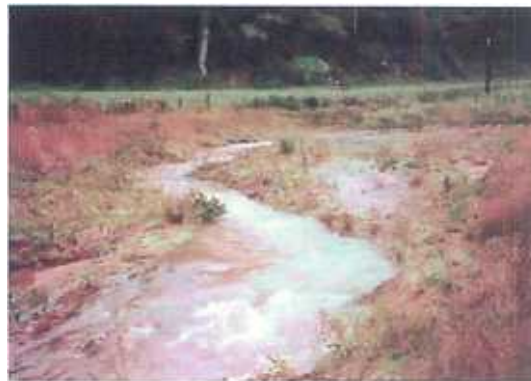
LUS stn. 8+90 after work & during flood September 27, 2002

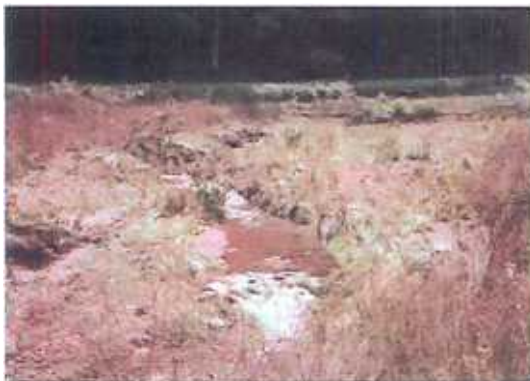
LUS stn. 8+90 after flood October 4, 2002

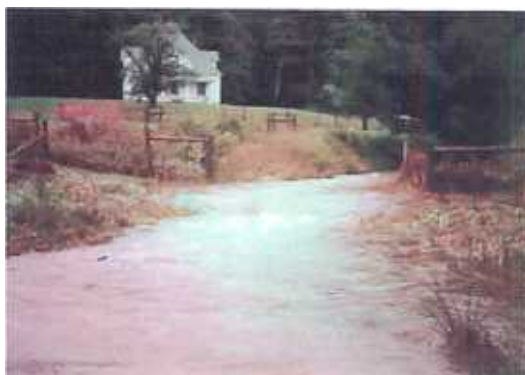
LUS to stn. 10+54 during flood September 27, 2002

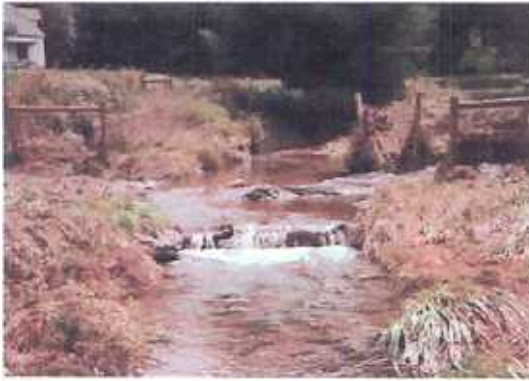
LUS stn. 10+54 after flood October 4, 2002

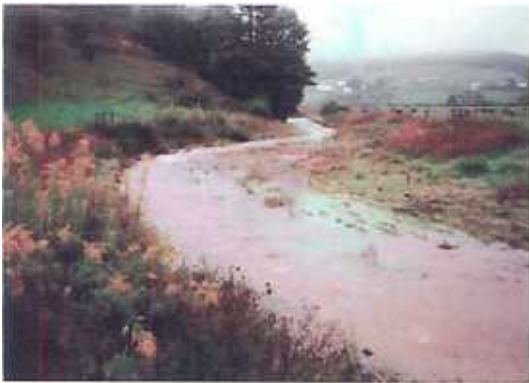
LDS stn. 10+79 after work & during flood  
September 27, 2002

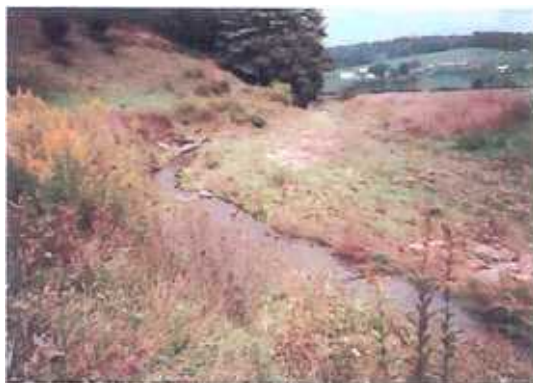
LDS stn. 10+79 after flood October 4, 2002

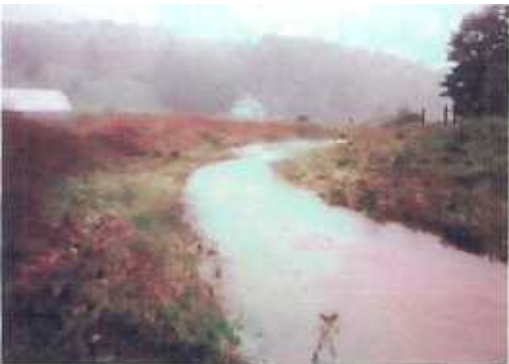
LUS stn. 18+26 during flood September 27, 2002

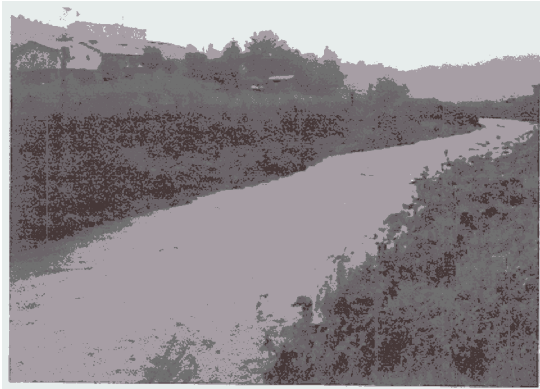
LDS stn. 20+47 after work & during flood  
September 27, 2002

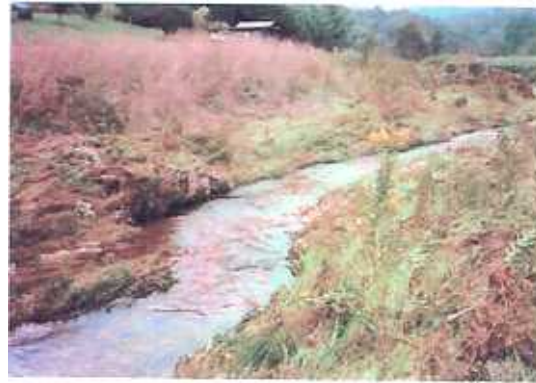
LDS stn. 20+47 after flood October 4, 2002

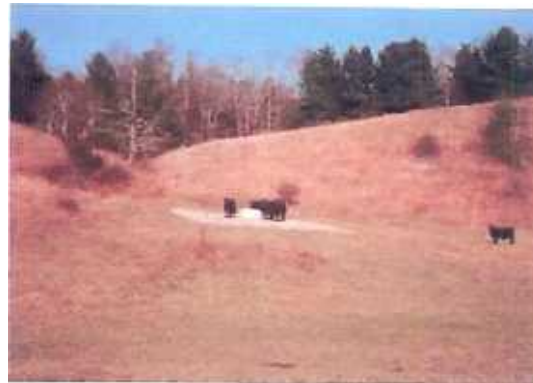
Livestock using water tank # 3 October 8, 2002

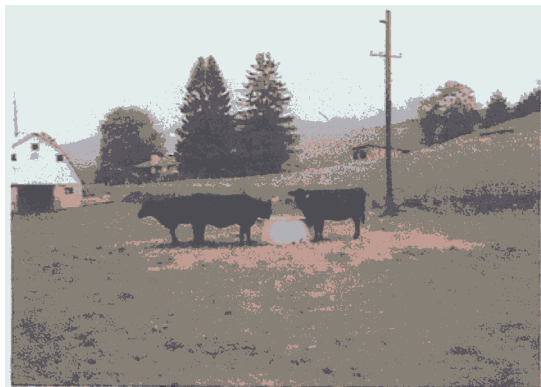
Livestock using water tank # 2 October 4, 2002
